Mini-Architectural Assessment of the Hlatshana Farmstead, 220 Murray Road, Hayfields, Pietermaritzburg

Prepared for: **Amafa a KwaZulu-Natali**
195 Longmarket Street
Pietermaritzburg
3200
July 2009

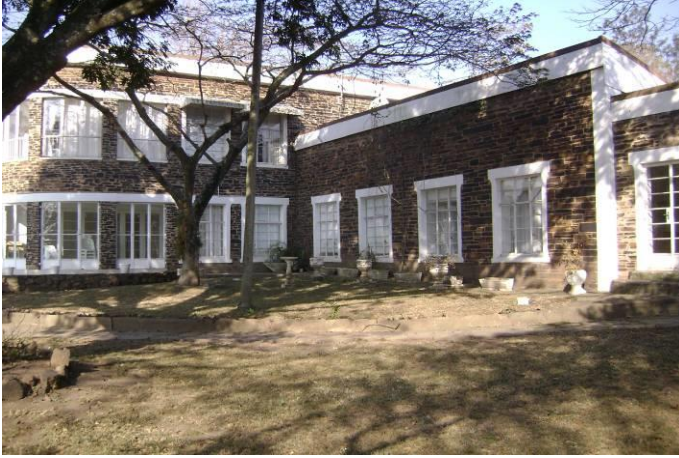
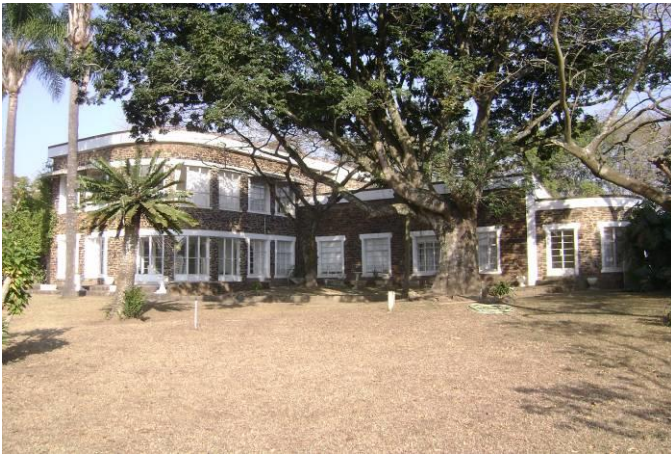
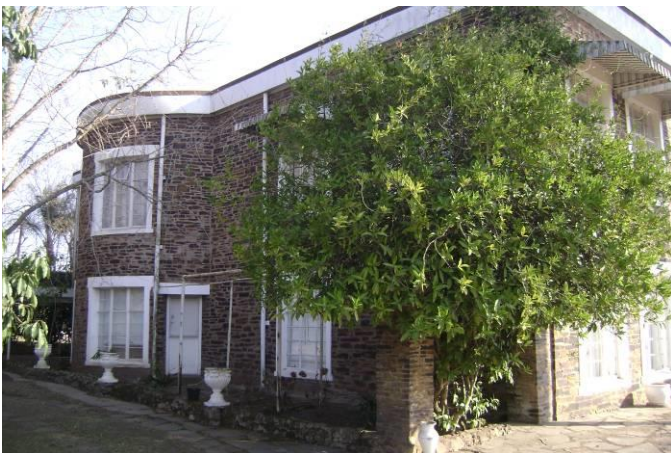
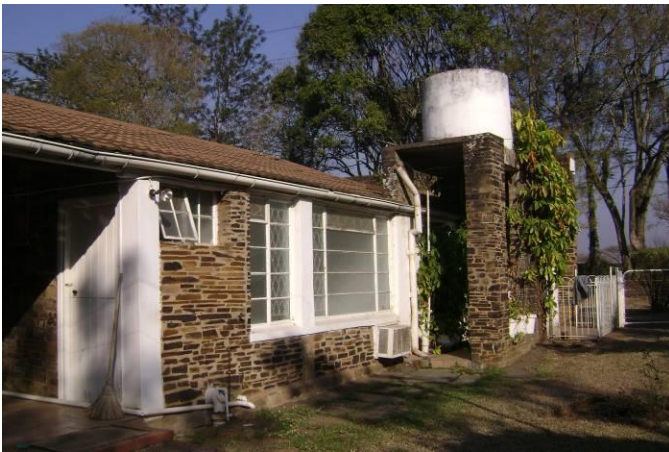
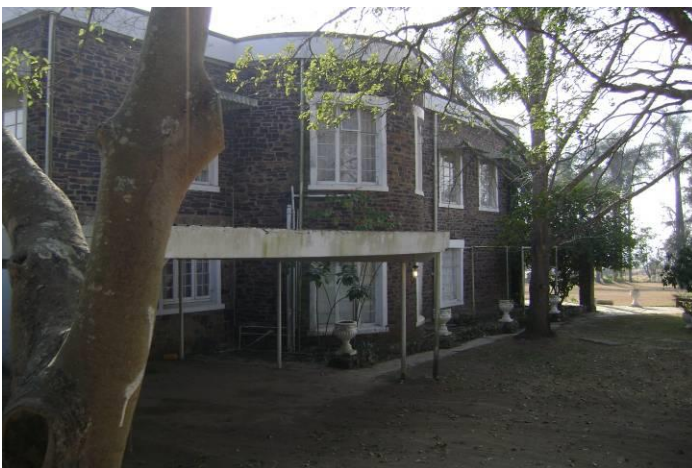
On entrance from Murray Road, a sweeping pergola of stonework forms a screen to the utility section, and directs the visitor to the south, to the main entrance way. The massing of the house is a main two story volume orientated east west with a parapet running around the periphery that conceals the fall of the roof below. This appears to have been added on in the 1970's.

The elevations around the house are consistent- a mix between a Georgian aesthetic and a modernist paradigm, with banks of equally proportioned windows continuing an aesthetic flow. The condition of the structure is good, and it forms an imposing landmark in the area.

Fig 2: main house from north-east

Fig 3: main house from north-east

Fig 4: main house from south east

Fig 6: main house from kitchen

Fig 7: main house from south-west

The position of the house creates an entrance to the farmstead located to the north. It is a solid and imposing structure and is in good condition. It is a singular example of a vernacular modernism which combines the palimpsests of historical development on earlier structures. It is an unique example of a working farmstead in close proximity to the city, as well as having associations with historic events and people.

The main house is a good example of a vernacular form of the Bauhaus Modernist movement, rare in KwaZulu-Natal and should be kept and reused. It is in good condition, and the opportunity exists for reworking the interior spaces to form an elegant series of rooms for reuse.

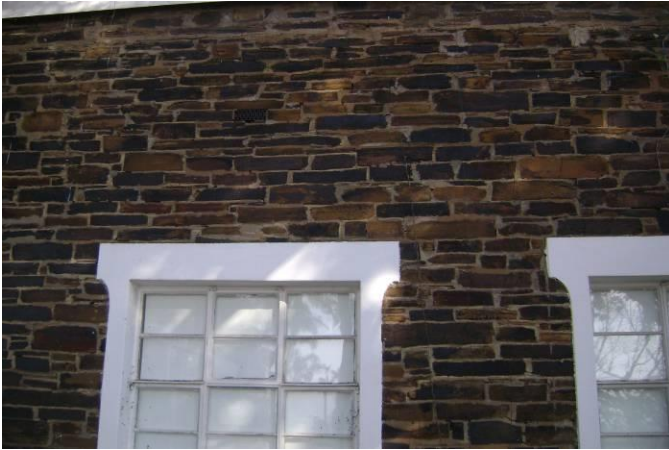
The main house is unusual as it is one of the few representatives of Bauhaus-type modernism in Pietermaritzburg, and especially so as it is constructed of vernacular material (shale) rather than plastered and painted white or of brick. It is understood that the house occupies the site of an earlier, Victorian structure, which formed part of the original farmstead. (an inspection of the Land Registers would illuminate further on the property divisions and owners of the house)

Fig 5: detail of window plaster and shale wall

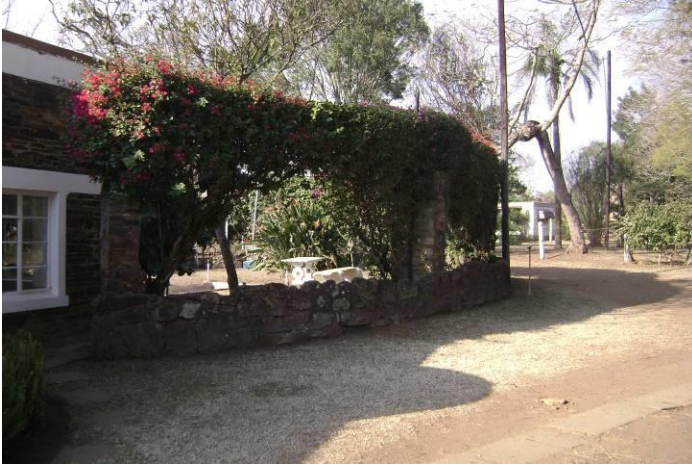
Fig 8: main house from entrance showing shape constructed pergola

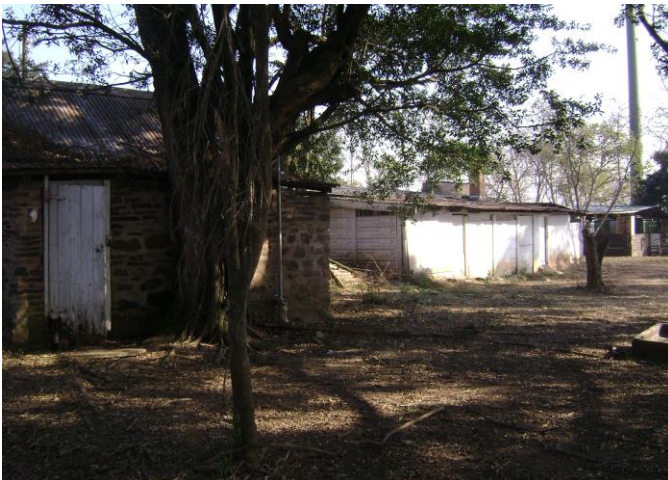
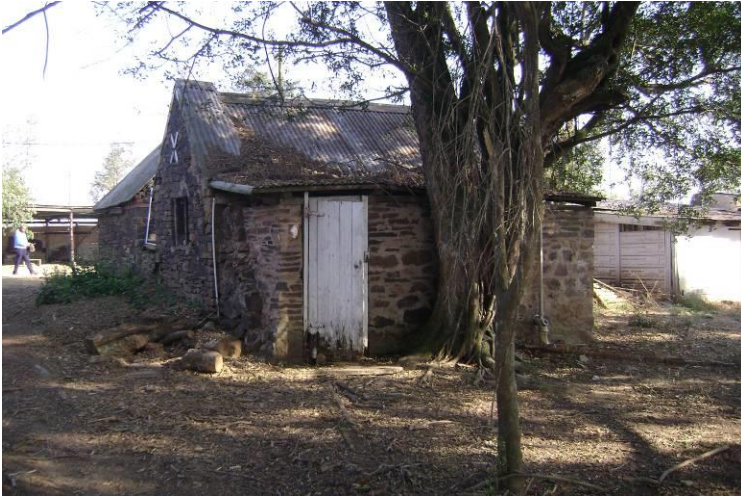
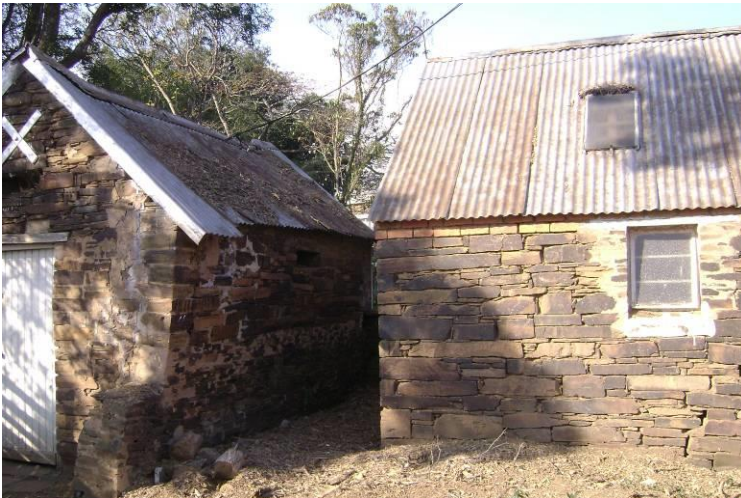
Outbuilding 1 consists of two shale structures under a double-pitched corrugated iron sheeting roof. They are connected, but are orientated in opposition. The building which is located on the farmyard has a skylight to the north, and the second building has a tie rod in the gable with a spreader bar in the form of a cross. Given the nature of the materials used and the genre of construction, these structures would feasibly date to the mid to late -nineteenth century. In addition, it understood that these may have been used as an armoury during the Anglo-Boer War.

Fig 9: Outbuilding no 1 from south east showing rear of outbuilding 2

Fig 10: outbuilding 1 from south east

Fig 11: Outbuilding no 1 from north east showing tree growing onto the addition

The condition of these structures is good, given their age. This structure does form part of a group comprising the farmyard.

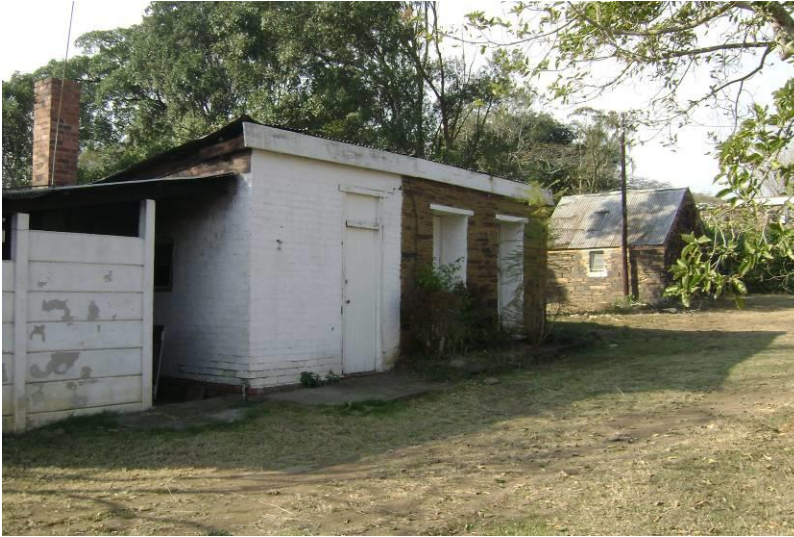
Outbuilding 2 is part shale, part recent brickwork and part painted 'watcrete' type prefabricated concrete wall. The main part of the building is under mono-pitch corrugated iron sheeting. The original structure, being the shale building, appears to have been added onto through accretions over the years. The structures are generally in good condition. This structure does form part of a group comprising the farmyard.

Fig 13: outbuilding 2 from main farmyard showing outbuilding 1 behind

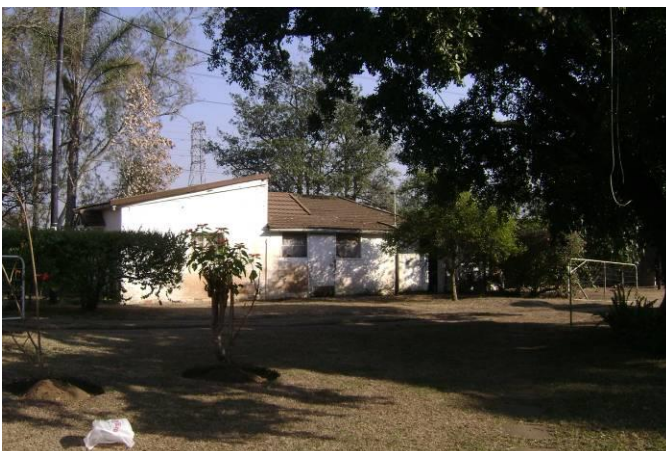
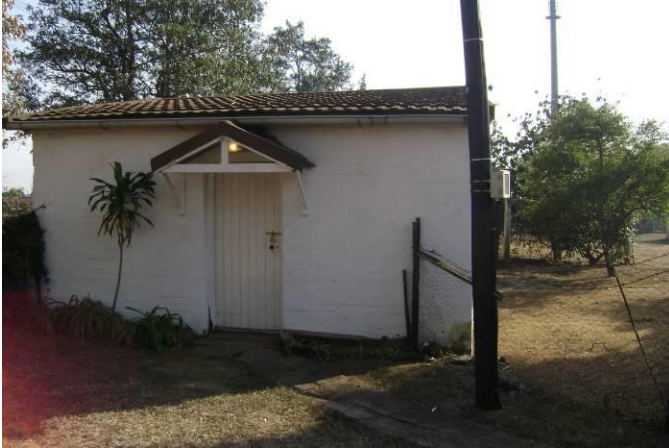
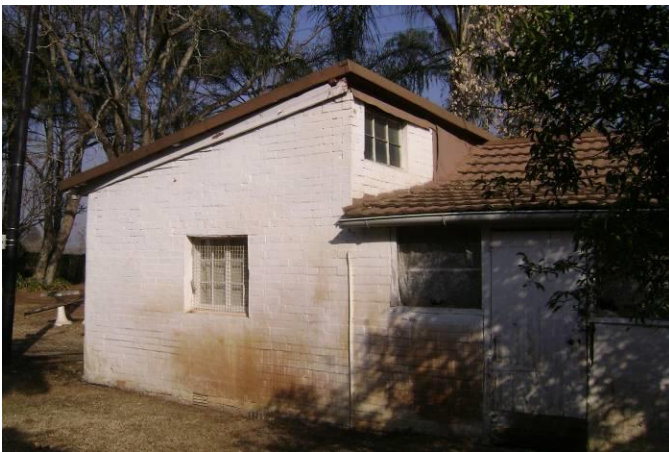
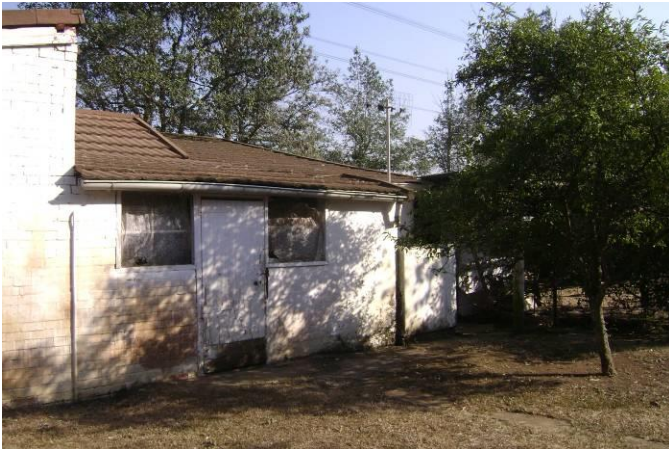
Outbuilding 3 is located at the entrance to the farmyard and has elements of earlier structures constructed of brick (painted white) which have been subsumed by concrete block. It consists of a number of different elements under a Harveytile roof which has disparate pitches and an incoherent architectural language. This structure does form part of a group comprising the farmyard.

Fig 14: outbuilding 3 showing disparate roof pitches

Fig 15: outbuilding 3 from entrance to property

Fig 16: outbuilding 3 from farmyard

Fig 17: outbuilding 3 from entrance

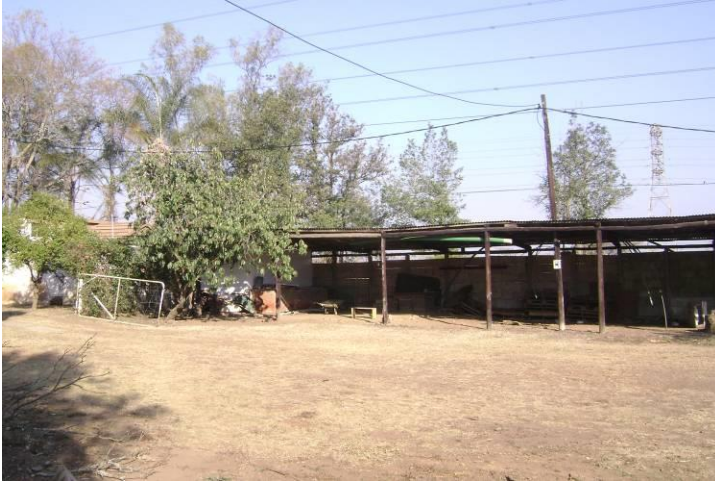
Fig 18: showing open shed connecting outbuilding 3 and the stables

The open barn is of no significance, being in poor condition but does serve as a linking mechanism in connecting the yard as a whole.

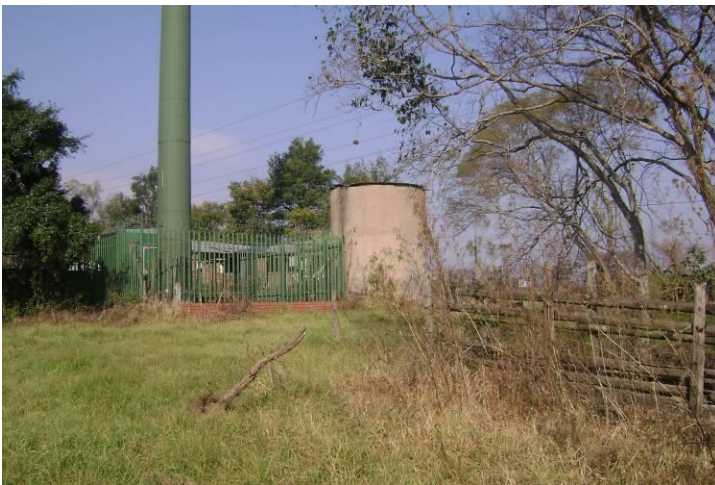
This L-shaped complex consists of open sheds under corrugated sheeting, an old shale feed barn dating back to the nineteenth century, stables and accommodation tucked into the corner which are most likely contemporary with the barn, given the corrugated sheeting (gospel oak) and constructed trusses. This structure serves to enclose the yard, with outbuildings 1,2 and 3 forming the other components. Hard against the barn is a reservoir and a mobile phone tower.

Fig 19: mobile phone tower and reservoir to north of the barn

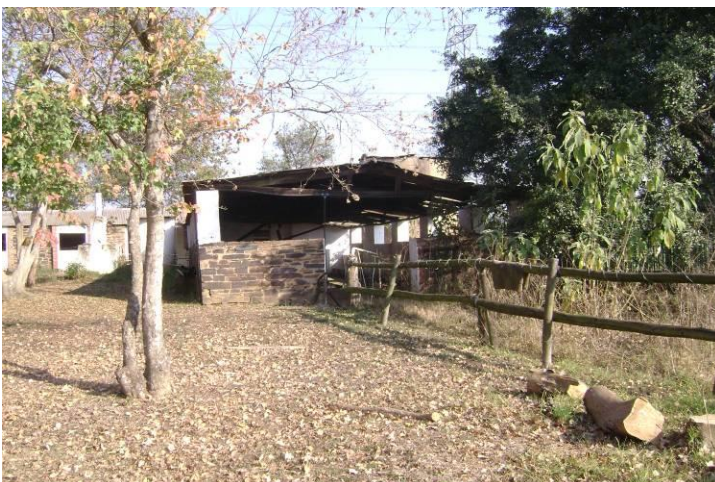
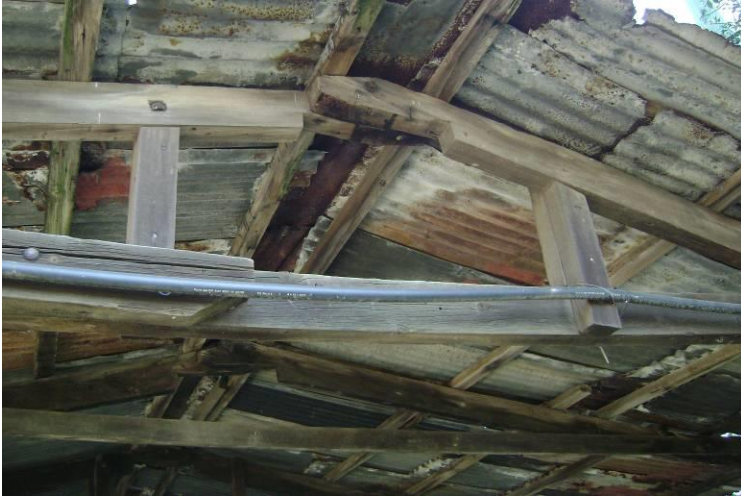
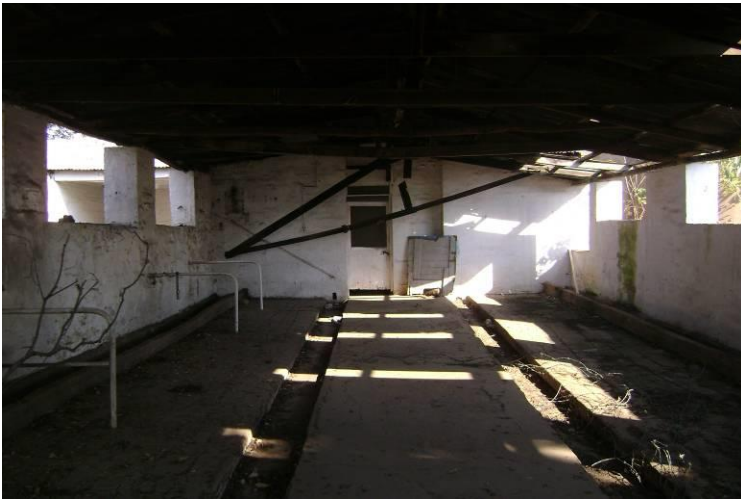
Fig 20: barn from east with stables in the background

Fig 21: showing condition of sheeting and trusses

Fig 22: interior of barn showing collapsed truss at end

The old barn is of shale with corrugated sheeting, is reasonably substantial in terms of scale, and apart from collapsing timbers, is in reasonable condition. This structure does form part of a group comprising the farmyard.

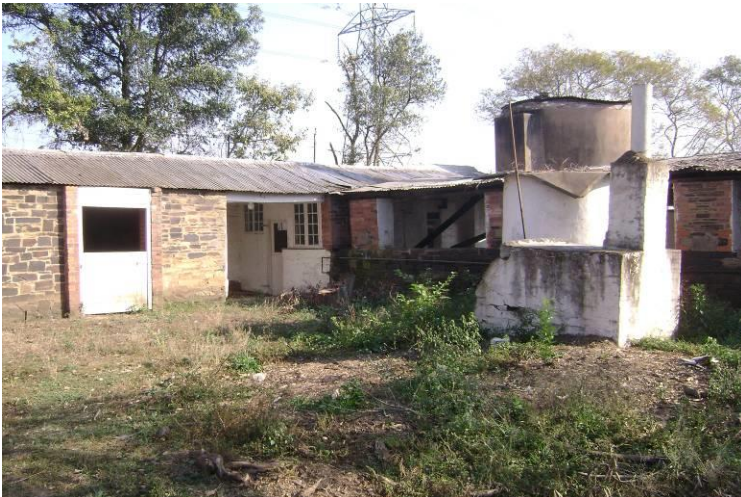
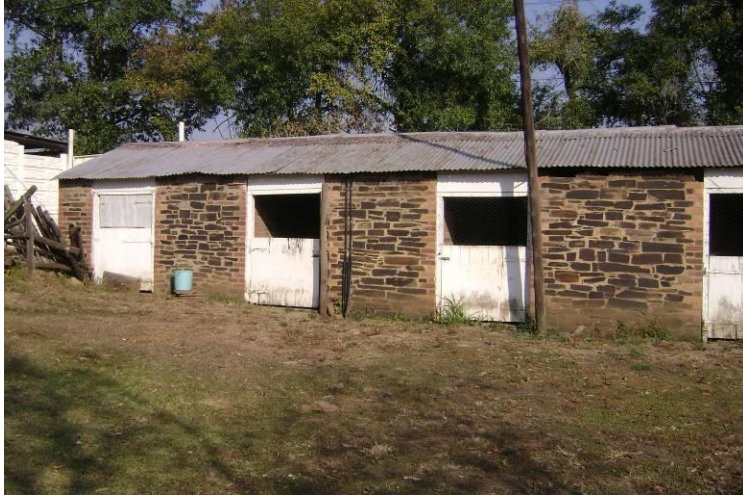
Fig 23: showing accommodation in the corner and the stables to the left

Fig 24: showing stable block connecting open barn and accommodation

The stable block is of shale and brick under corrugated sheeting and is in relatively good condition. It forms an important architectural element in rhythm and consistency. The accommodation (or perhaps feed room) located in the corner is of brick painted white.

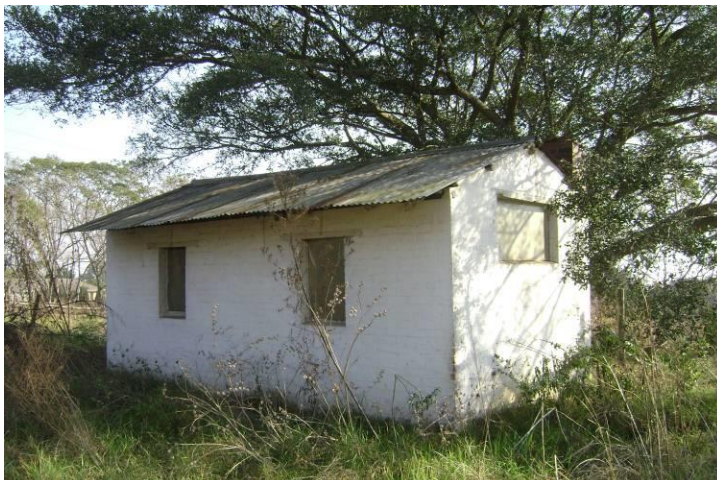
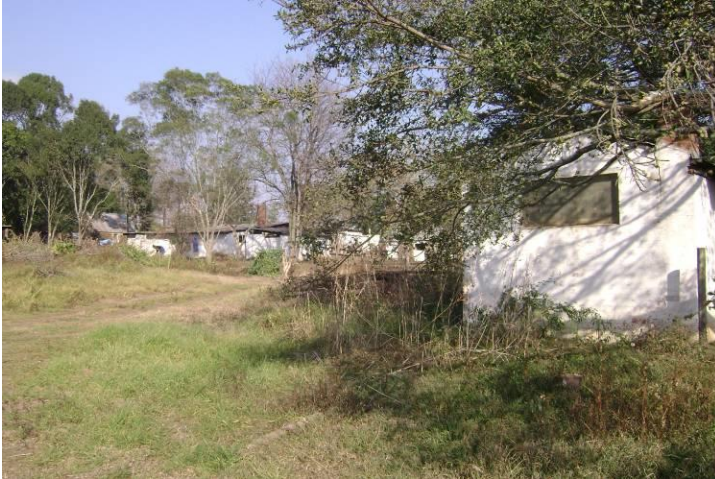
This is a free- standing structure that does not form part of the farmyard group. It is of more recent construction, and it is doubted whether it is likely to have been constructed over 60 years ago. It is a simple white painted un-plastered building, with a double-pitched corrugated sheeting roof and appears to have functioned as accommodation.

Fig 25: Outbuilding 5 from south east

Fig 25: outbuilding 5 from east showing location of the farmstead in the distance

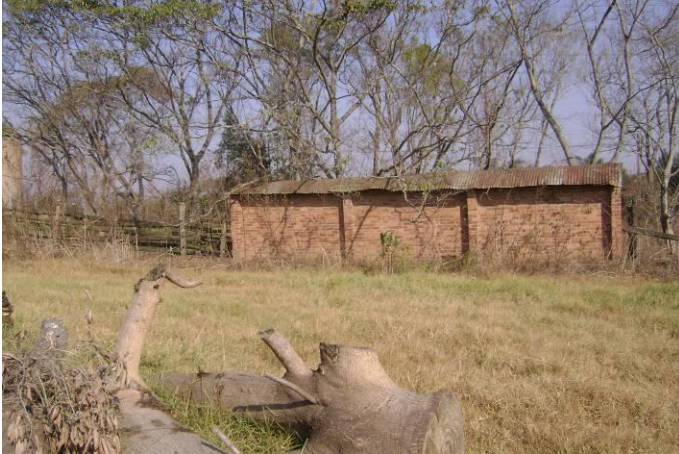
Outbuilding 6 is a brick constructed stock run which is located far from the farmstead. It has a cranked corrugated sheeting roof. It is of recent construction.

Fig 26: stock run

Fig 27: stock run from east

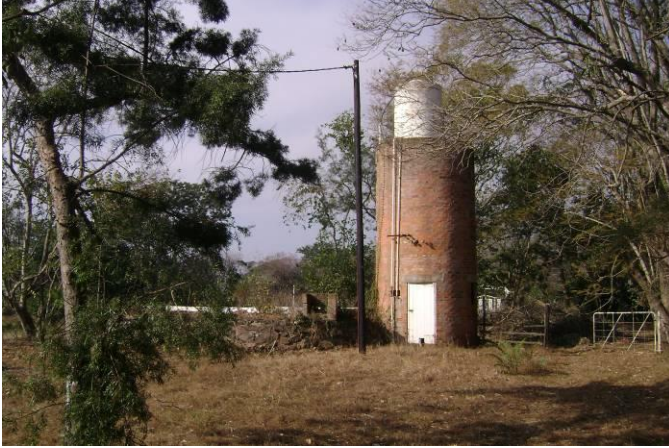
Outbuilding 8 consists of a reservoir constructed of shale and a water tank base constructed of brick. It is located distant from the rest of the structures and elements of it are more than likely to date to the early settlement of the farm. This structure does not form part of a group comprising the farmyard.
